TECHNICAL BULLETIN

Author: Bill Detherage	Bulletin # SB-1011
Verification: Greg Hoop / Bob Morosic	Date Issued: 12/09/2011
Product: 5501 Audio Consoles 5501-2, 5501-4, 5501-8, & 5501-12	Date Revised:

Subject:
5501 Audio Console – Incoming Audio Issue

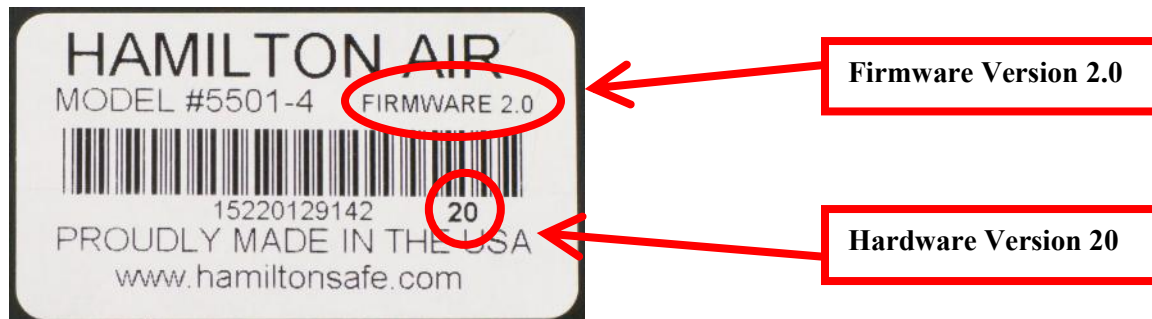
5501 Console Label on bottom of console

The issue and upgrade only applies to 5501 series consoles shipped September 1, 2011 and later with version 2.0 hardware and revision 2.0 firmware. **5501 series consoles shipped prior to September 1, 2011 with version 1.# hardware and revision 1.# firmware are not affected and are not part of this upgrade.** This information can be found on the serial number label on the bottom of the console. The hardware version is shown with bold numbers on the right side of the label below the bar code. **20** would indicate version 2.0. The firmware revision is listed above the bar code. The serial number label will be modified to show hardware version **21** and firmware revision 2.1 on units that have been upgraded.

Please use RGA form on the dealer's home page of the Hamilton Safe website www.hamiltonsafe.com to request upgraded consoles for each customer location with version **20** consoles. (If necessary you can call the location and have a teller verify the console version.) Provide the number of consoles and their keypad size (number of lane buttons) for each location. The upgrades will have to be done in stages so please request the RGA numbers for known problem sites first and return the old consoles as soon as they have been replaced. Replacement consoles will be shipped without the cable and the plastic tab with lane colors. Simply move the plastic tab from the existing console to the replacement console and reuse the existing cable.
