HAMILTON SAFE COMPANY PRODUCT NOTIFICATION

Document Date: 6/1/2005

Product Name: **Entrance Control Sys.**

***** Product Notification Message *****

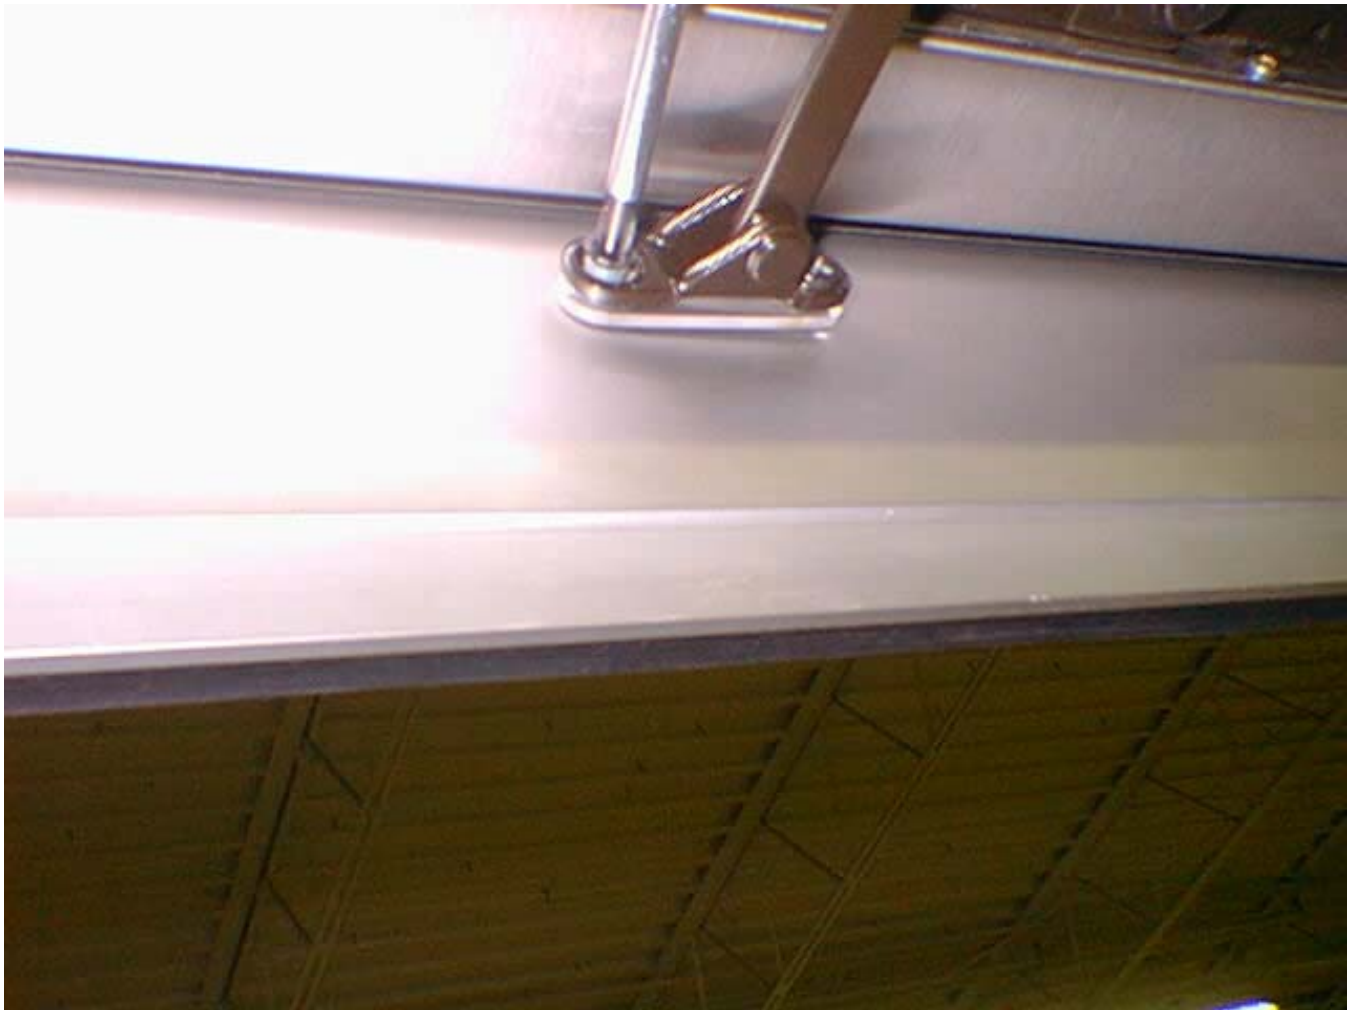
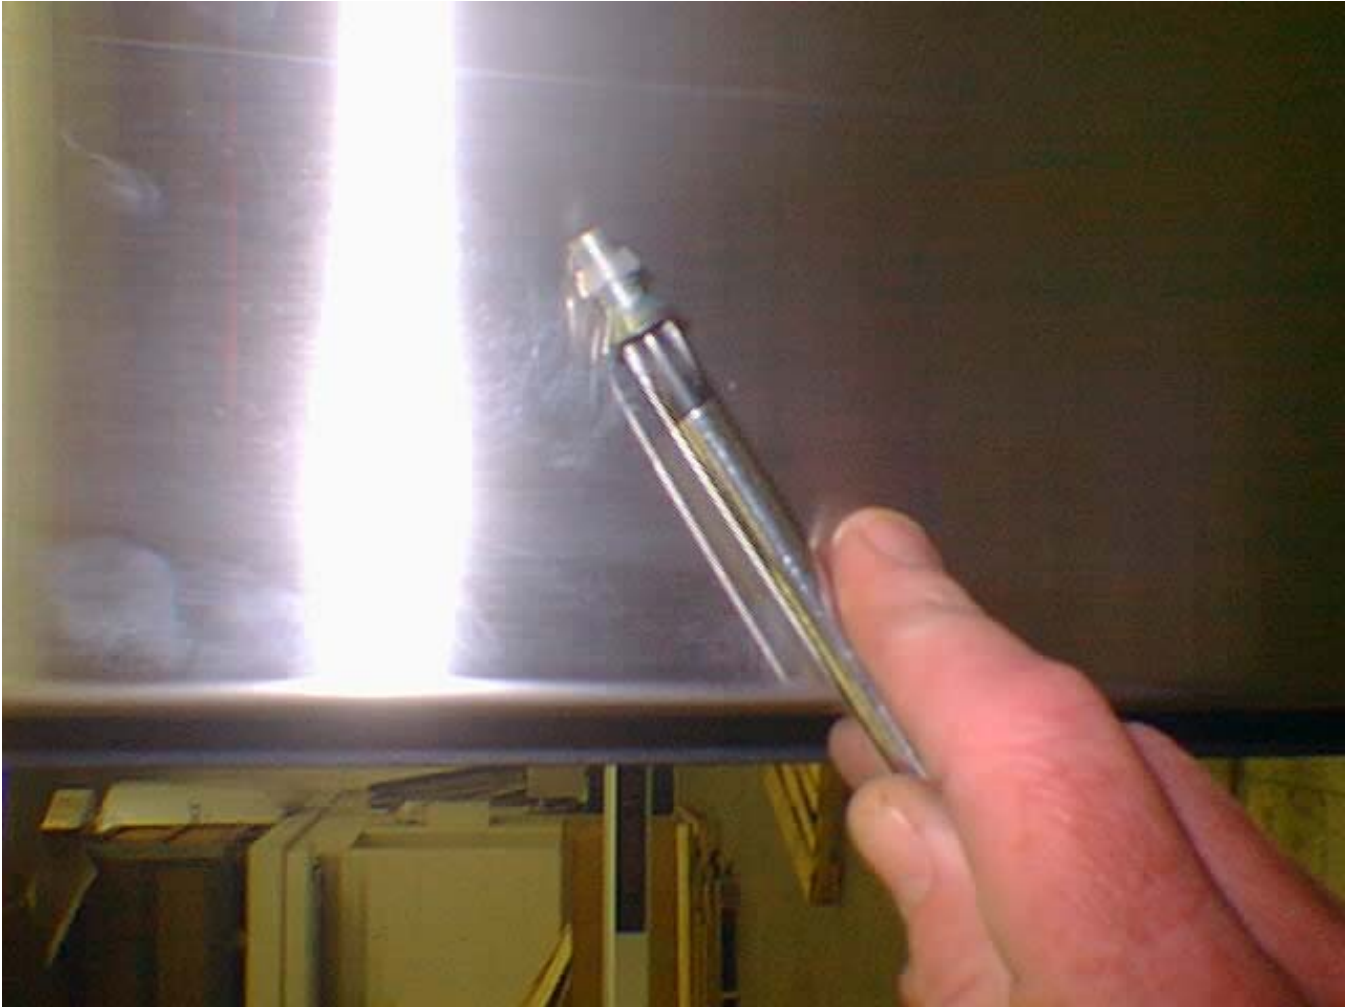
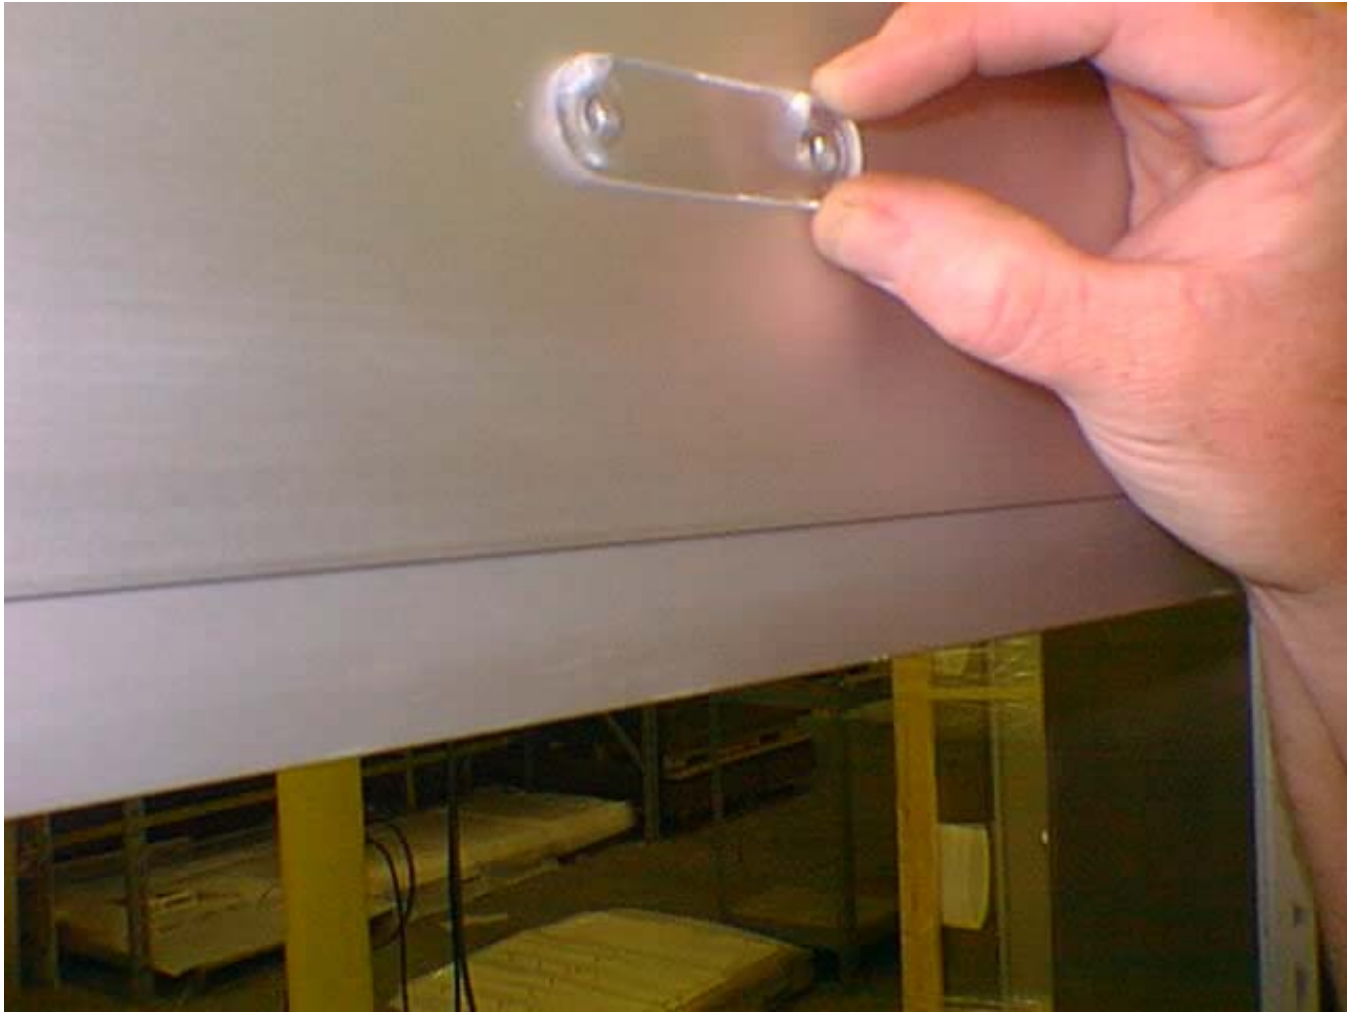
Symptom: **Metal detector sends a false alarm as doors are opened.**

The problem presents itself when the door closer creates a loop. The problem occurs in the field after the paint is scratched off allowing conductivity to exist that creates the undesired loop. If you are getting false alarms and want to verify this is your problem simply disconnect the closer and try the system again to see if it continues to false alarm. If problem goes away then simply order the kit (see below) and if problem persists this is not your problem.

We have eliminated the problem by insulating the door closer. We will send you out an isolation kit at no charge. Please reference part number: ECSISOKIT when placing your order.

(See attached photos to aid installation)
